HMAS SYDNEY II SEARCH PRESS ROOM

Latest Search Reports

4th April 2008 - Report

David Mearns – Search Director, The Finding Sydney Foundation

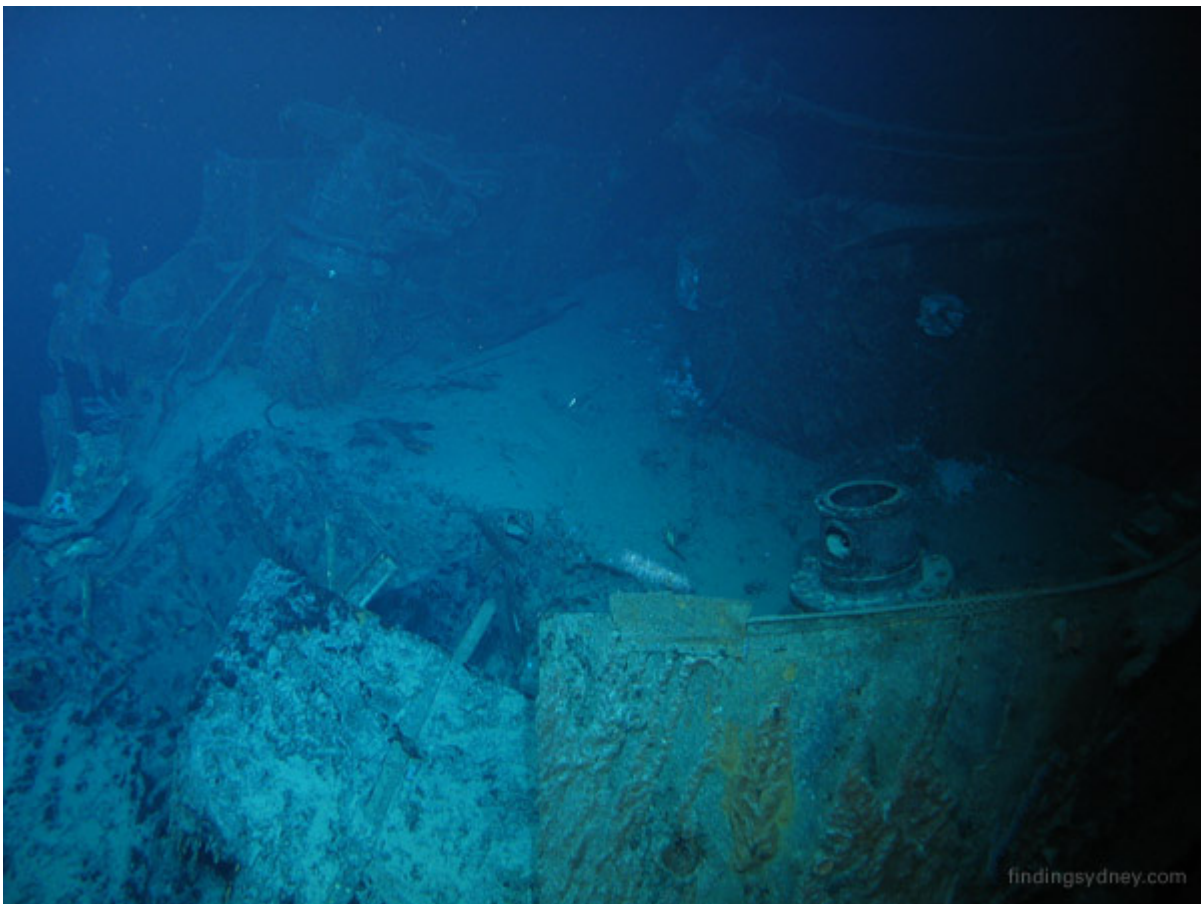
Above Photograph: Sydney's badly damaged compass platform, bridge and remnants of the base of the Director Control Tower.

Further evidence of the fierceness of the engagement came when we returned to the bridge and forward superstructure. The base of the Director Control Tower had received a direct hit which had punched through it from the starboard side and exited through the port side leaving a gaping hole. The compass platform and bridge was a shambles and the forward screen below it had partially collapsed and was pushed back at an angle of about twenty degrees. On viewing this level of destruction, a hushed silence fell over the survey room as we continued to maneuver the ROV towards the rear of the ship.

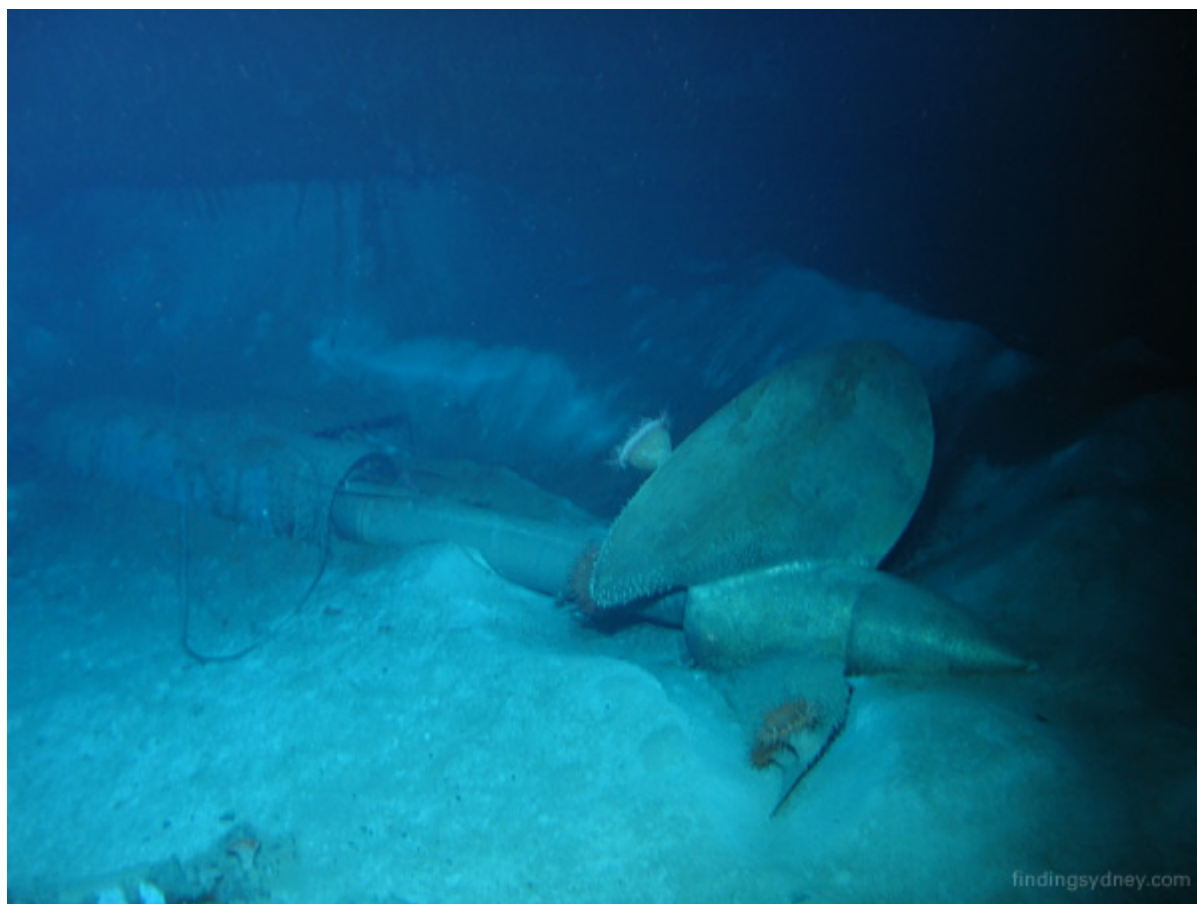
Above Photograph: One of Sydney's port propellers and shafts dislocated from its normal position against the hull.

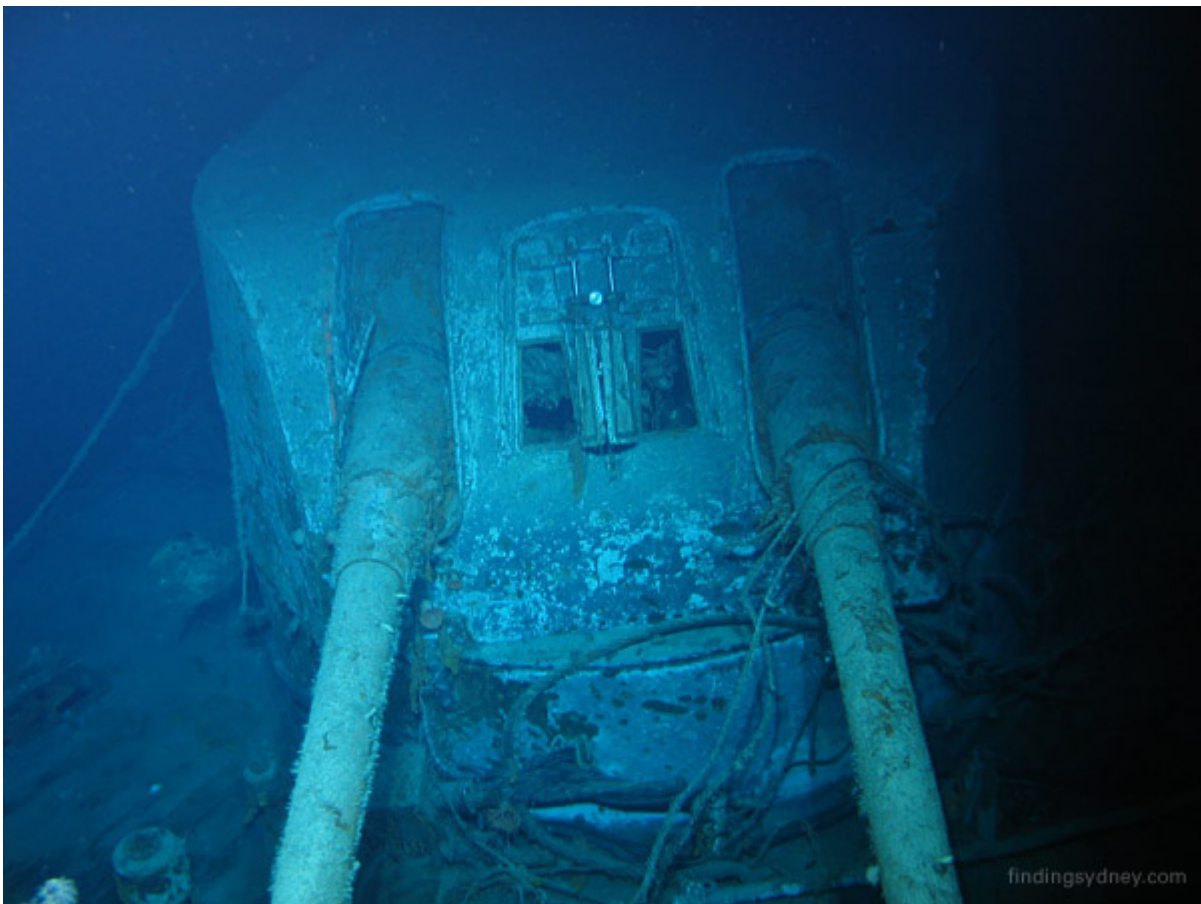
Above Photograph: The front of the gun housing of "X" turret, credited by the Germans with inflicting the mortal blow on Kormoran.

The second image speaks volumes for the bravery of Sydney's own gunners closed up in "X" turret. The men in this turret - the forward of Sydney's two stern guns - have been credited by their German adversaries for firing the shells that ultimately led to Kormoran's demise. Because Sydney's bridge and director control tower were destroyed at the start of the battle it is now clear that the men in "X" turret must have been shooting independently in local control. Our pictures of "X" turret not only show it pointing forward frozen in its final shooting position but they also reveal the turret's two forward hatches swung wide open, possibly to allow better aiming and firing by the gunners inside. Despite their heroics, the men in "X" turret sadly met a similar fate to those in "A" and "B" as evident by the shell hits on its base.

When we came to 'X' turret which, according to the Kormoran survivors had fought on valiantly and dealt the German raider a mortal blow, we were amazed to find that as with 'A' and 'B' turrets she too had received two well placed shell hits in the front of her gun housing low between her gun barrels which were fully depressed. Draped over the top of 'Y' turret is what we believe to be the remnants of the after funnel.

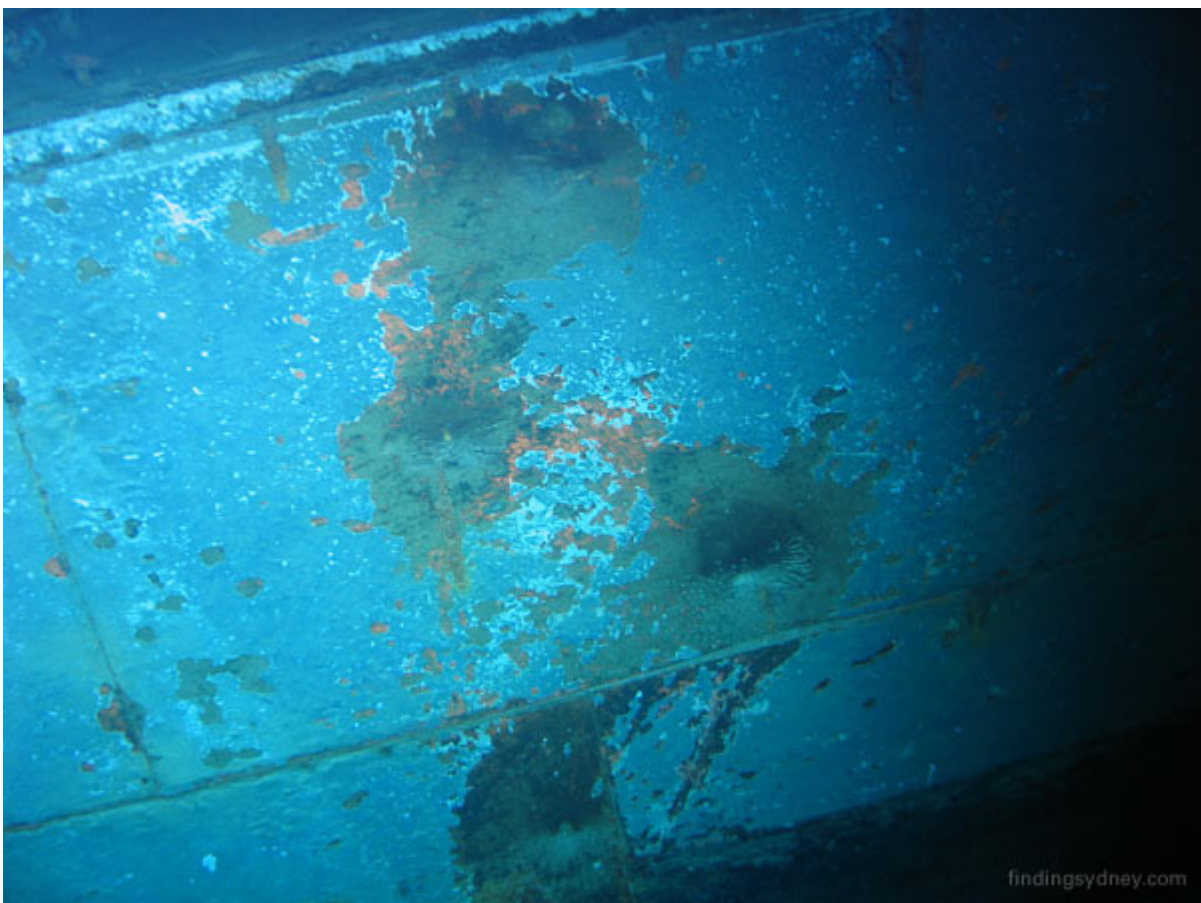
Above Photograph: This cluster of four 5.9-inch shell hits within a line 20-feet high clearly demonstrates the deadly precision of the German gunnery.

Of the many images of Sydney's wreck two struck me the most. The first was of a cluster of large calibre shell hits on Sydney's starboard side. Each 5.9-inch shell impacted against Sydney's four-inch thick belt of armour and hull plate that was protecting her vital engine room and boiler spaces. Whilst the shells did not fully penetrate the hull the damage and carnage they would have wreaked on the other side would have been enormous. The truly amazing aspect of this picture (shown below), however, is that each of the 4 shells - undoubtedly fired separately, but by the same gun on Kormoran - all hit within a cluster only 20-foot high. This image illustrates with terrifying reality the rapidity and deadly precision of the German gunnery.

As with the port side, Sydney's 21-inch torpedo tubes were missing leaving only the ring gear, which once traversed them, remaining. Below this mounting were four closely grouped shell hits visible immediately below the main deck.
