# HMAS SYDNEY II SEARCH PRESS ROOM

HMAS SYDNEY SEARCH PTY LTD (SYDNEY SEARCH) AS TRUSTEE FOR  
THE FINDING SYDNEY FOUNDATION

### 5th April 2008 Report

## Photograph Location Guide

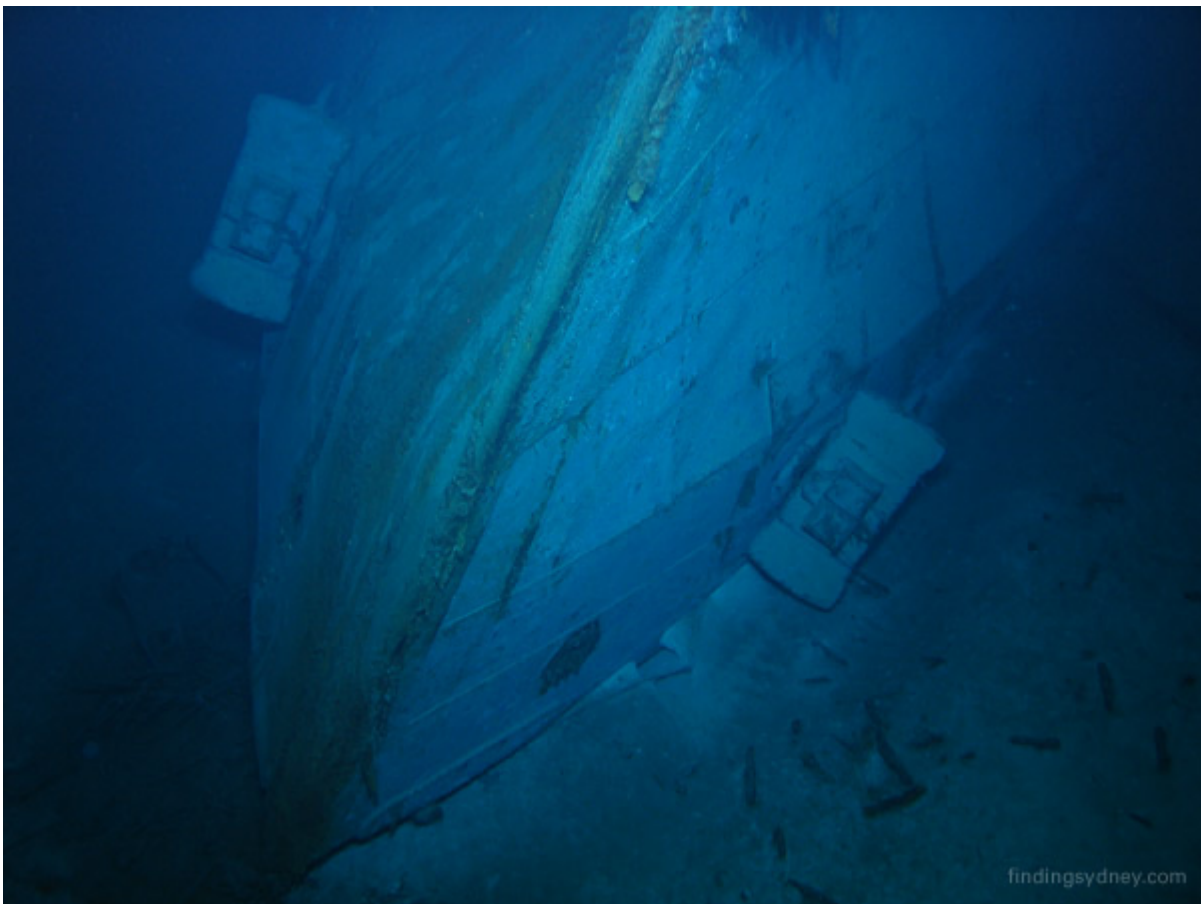
Above Photograph: Sydney's inverted bow was our first major discovery within the debris field.

There was anticipation as we approached our second target which we believed to be the bow of Sydney. The bow was inverted with both anchors and numerous scuttles (port holes) visible. The scuttles were counted from the bow to the break to determine the break had occurred in the vicinity of water tight bulkhead No 5.

Having obtained imagery of the foremast, the ROV was maneuvered toward the next large contact which turned out to be Sydney's severed bow lying upturned on the sea floor. Both of her anchors were all the way home in the hawse pipe and secure. We were able to determine where the bow had severed by counting the scuttles aft of the anchors. Totalling six, we concluded that the bow parted approximately 66 feet from the stem of the vessel. Lengths of chain cable were strewn in the vicinity of the bow and an inspection of the bows opening revealed that all of the forward decks within it had collapsed.

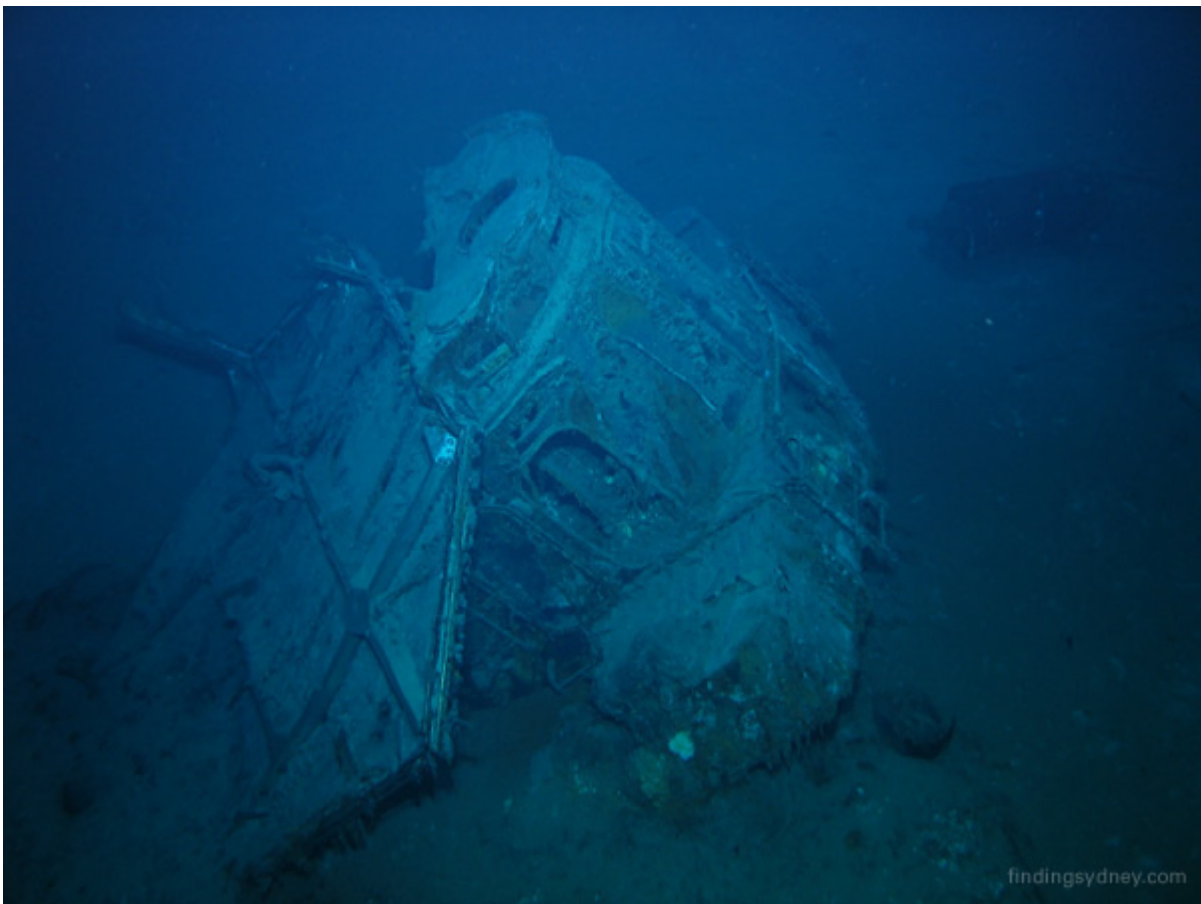
Above Photograph: The distinctive bridge deck head (roof) lying against the front of the Director Control Tower.

The ROV then carried out an inspection of the sea bed for other significant pieces of debris. Before long we came across a large structure which we were initially unable to identify. After some time we determined that it was actually two large pieces lying on top of each other. A close investigation soon revealed that we had found the distinctively shaped flat bridge roof top, resting over the front of the Director Control Tower.

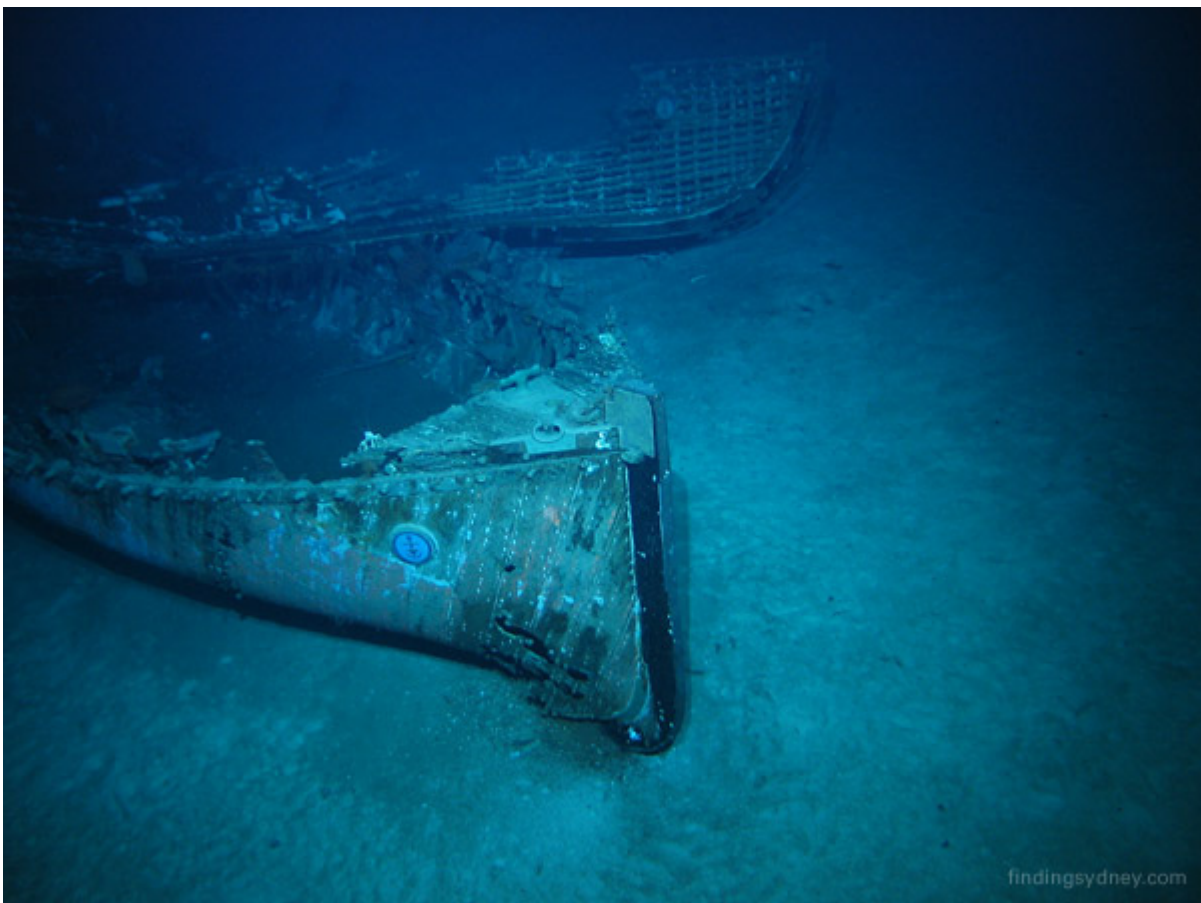
Above Photograph: Without doubt the most chilling find in the debris field was the presence of five of Sydney's life boats. Note Sydney's official badge mounted on their bows.

The discovery of the boats in the debris field was both remarkable and sobering. We were able to identify several different types of boats ranging in size from 27-foot whalers to the larger 35 and 36-foot motor cutters. Distinguishing features included the presence/absence of propulsion and the type of build such as clinker or carvel. Some showed signs of damage by gunfire and in one instance two of the boats were resting on top of one another. This certainly supported our earlier assessment that few of Sydney's boats were launched following the action. The most striking feature, however, was the presence of Sydney's badge mounted proudly on the bows of all boats found. These carefully hand painted coloured icons remain in tact, undisturbed, and will continue to serve as a silent epitaph to HMAS Sydney (II) and her valiant crew.

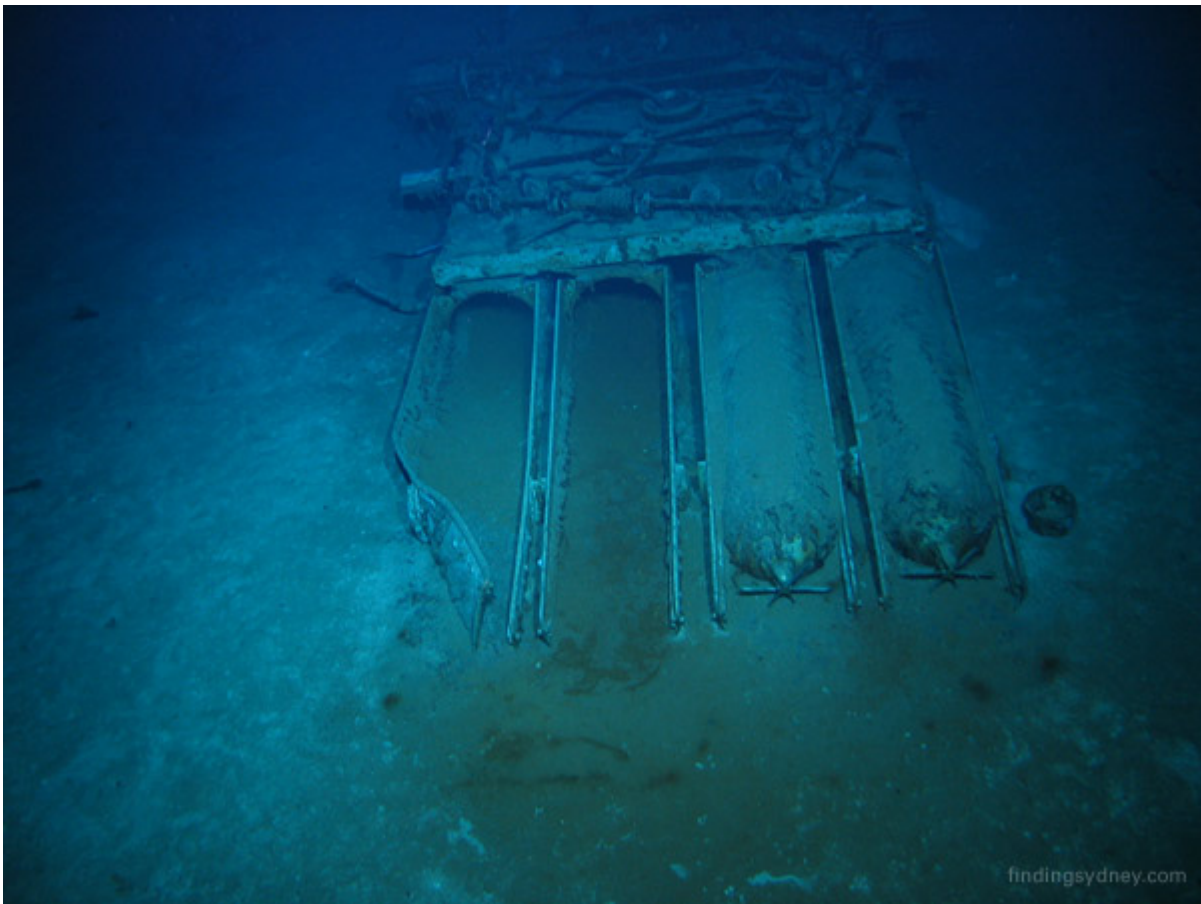
Above Photograph: One of Sydney's 21-inch quadruple torpedo tubes lying upside down on the sea bed. Two torpedoes remain in their tubes.

The finds continued to fill us with awe. Just prior to a tea break we saw the first of many black shoes. A torpedo trolley caused debate for some time as did a piece of debris with letterbox like slits. This turned out to be a boat cradle base. There was various shell cartridges and one torpedo, not far away from where the torpedo tubes, with two torpedoes still in the right hand side were located.
