HMAS SYDNEY II SEARCH PRESS ROOM

Latest Search Reports

7th April 2008 Report

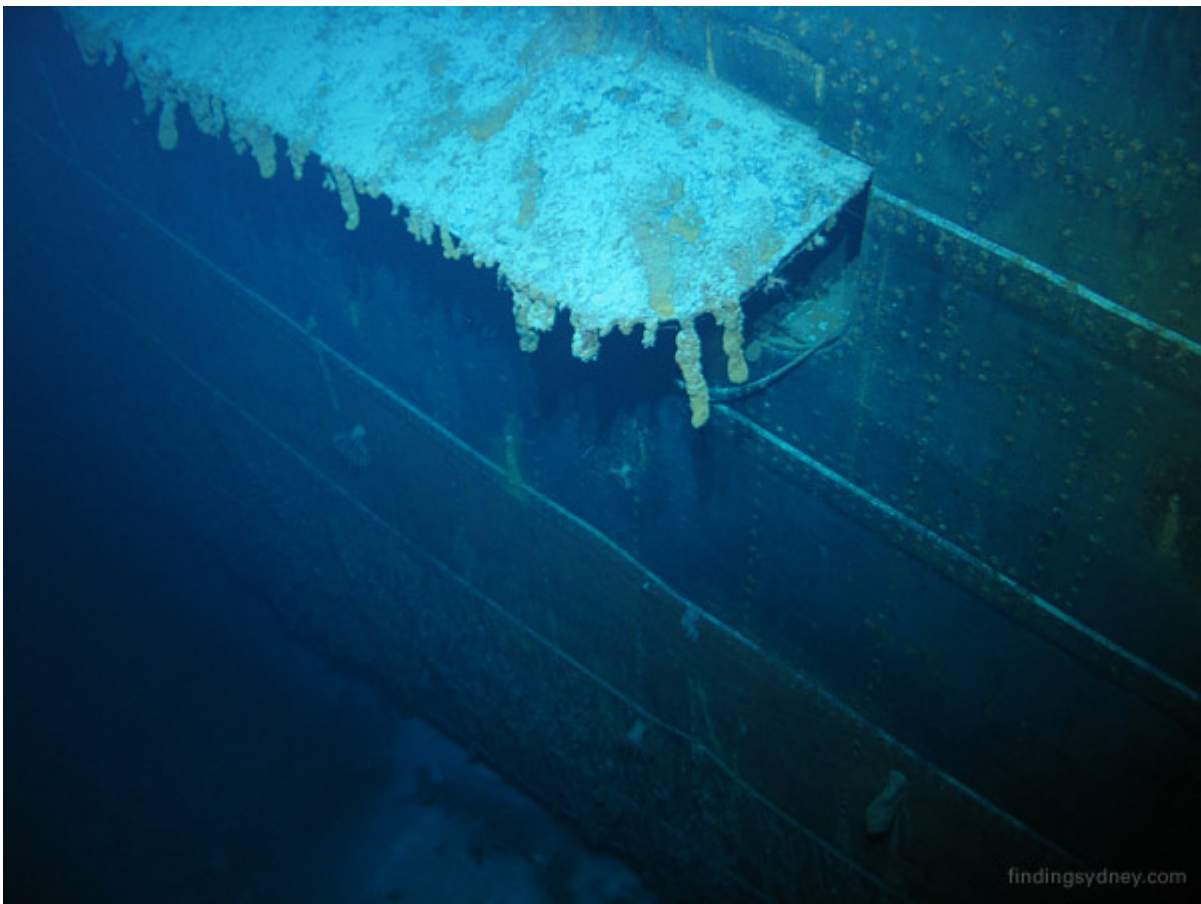
Above Photograph: The simple flap designed to conceal the starboard and port above-water torpedoes shown here on the starboard side in the open position.

The fore part of Kormoran immediately became our main target of interest and I was extremely interested to view this mysterious chameleon of the sea. We quickly identified the openings for her above water torpedo tubes which were easily identifiable by a rectangular steel plate flap which was in the open position, raised at 90 degrees. Unfortunately we were unable to get the ROV into a position to view inside the opening and therefore could not determine what state the torpedo tubes were in. As we manoeuvred the ROV lower down the ships port and stbd sides we found the oval openings for both of the fixed under water torpedo tubes.

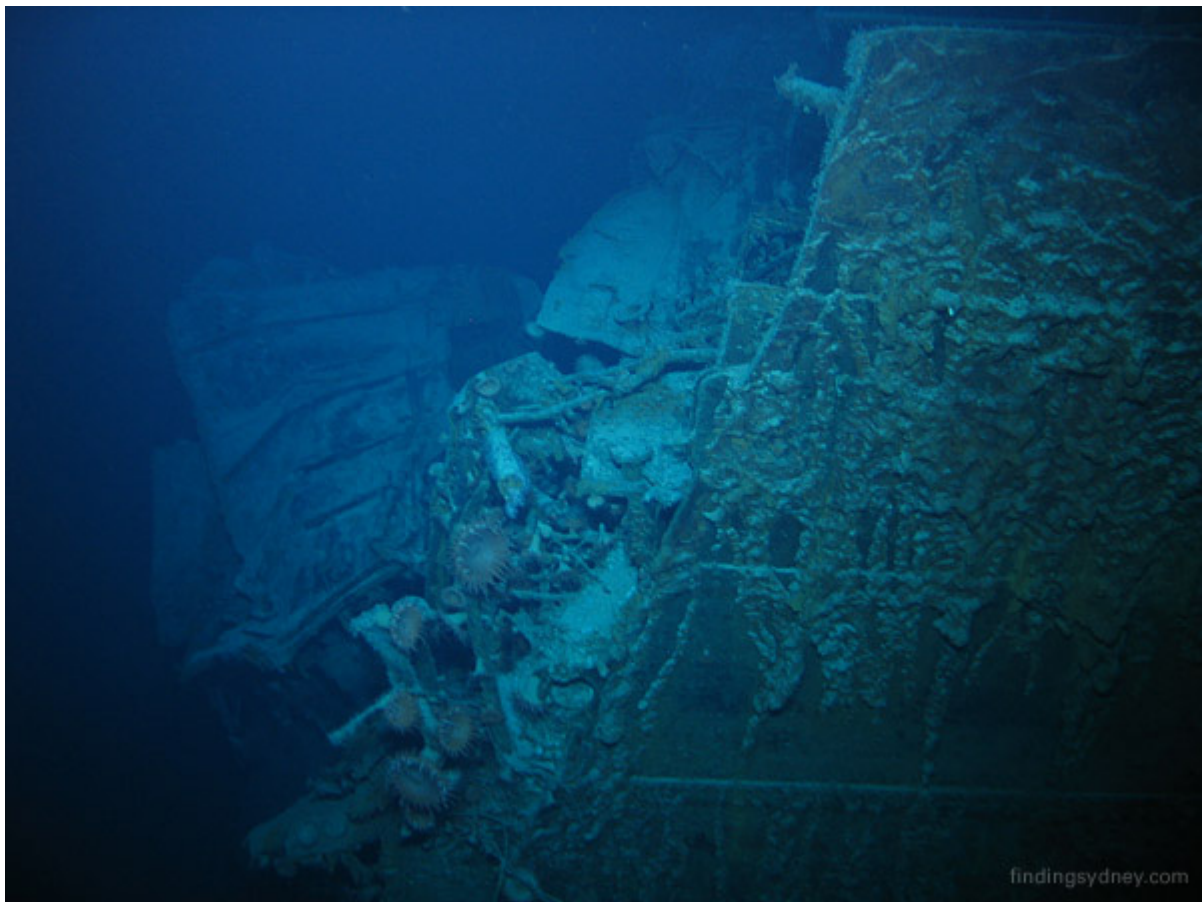
Above Photograph: The break in Kormoran's riveted steel hull bears testimony to the violence of the detonation caused by her scuttling charges and mines that sent her to the bottom.

As some of today's images will show most of Kormoran's hull has been absolutely obliterated by the final explosion, which reduced much of her structure to wreckage that is so completely twisted and torn it is virtually impossible to identify what part of the ship it comes from. I have no doubt that it was the simultaneous detonation of Kormoran's cache of over 300 mines that ripped her apart and left the scene of utter destruction we were witnessing. The German Captain Detmers and his fellow officers had vividly described this explosion but here was the proof, once again, that they were speaking the truth and this was plain for everyone to see for themselves. The most amazing thing was that Detmers - who left Kormoran last - and those in the last lifeboat with him somehow miraculously avoided being hit by this wreckage, which clearly rained down over an area covering hundreds of metres.

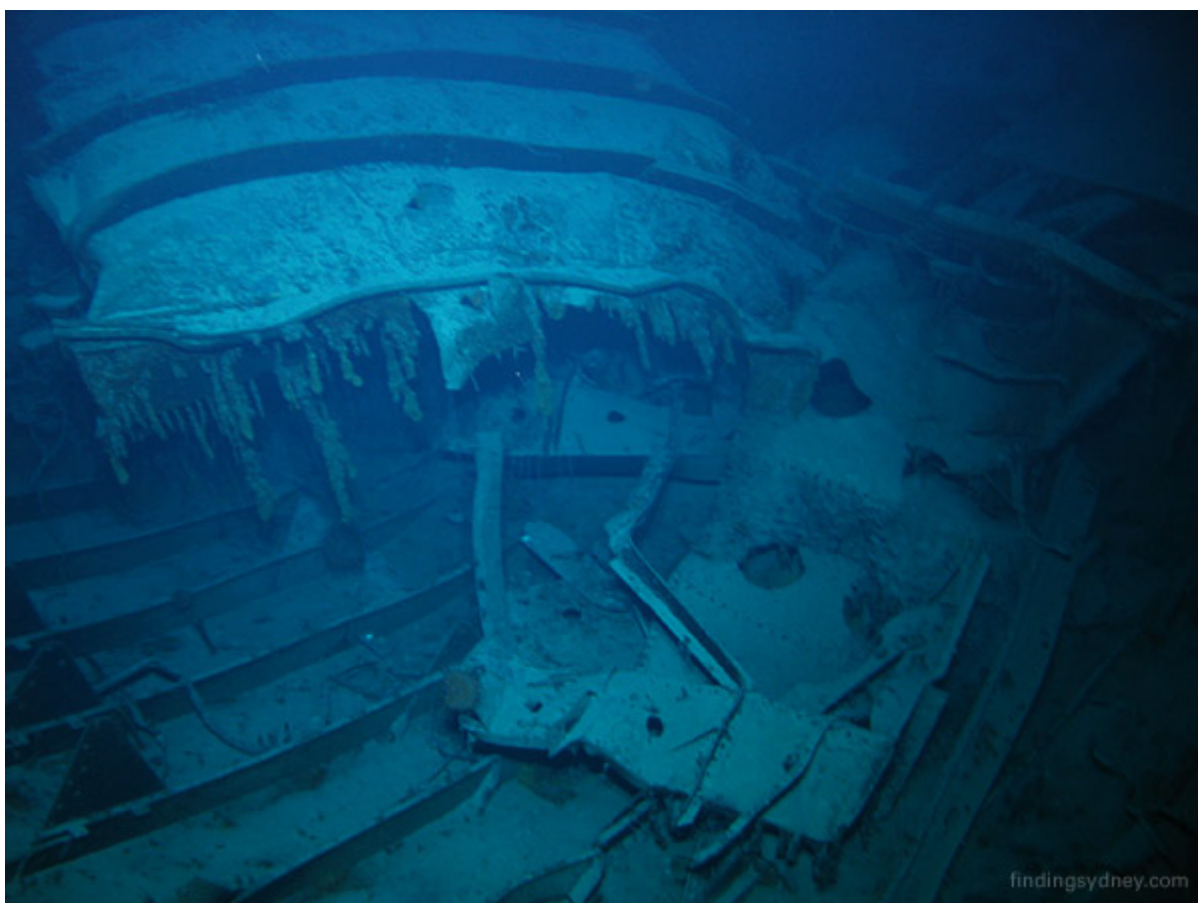
Above Photograph: An example of the many large pieces of twisted metal scattered throughout Kormoran's vast debris field.

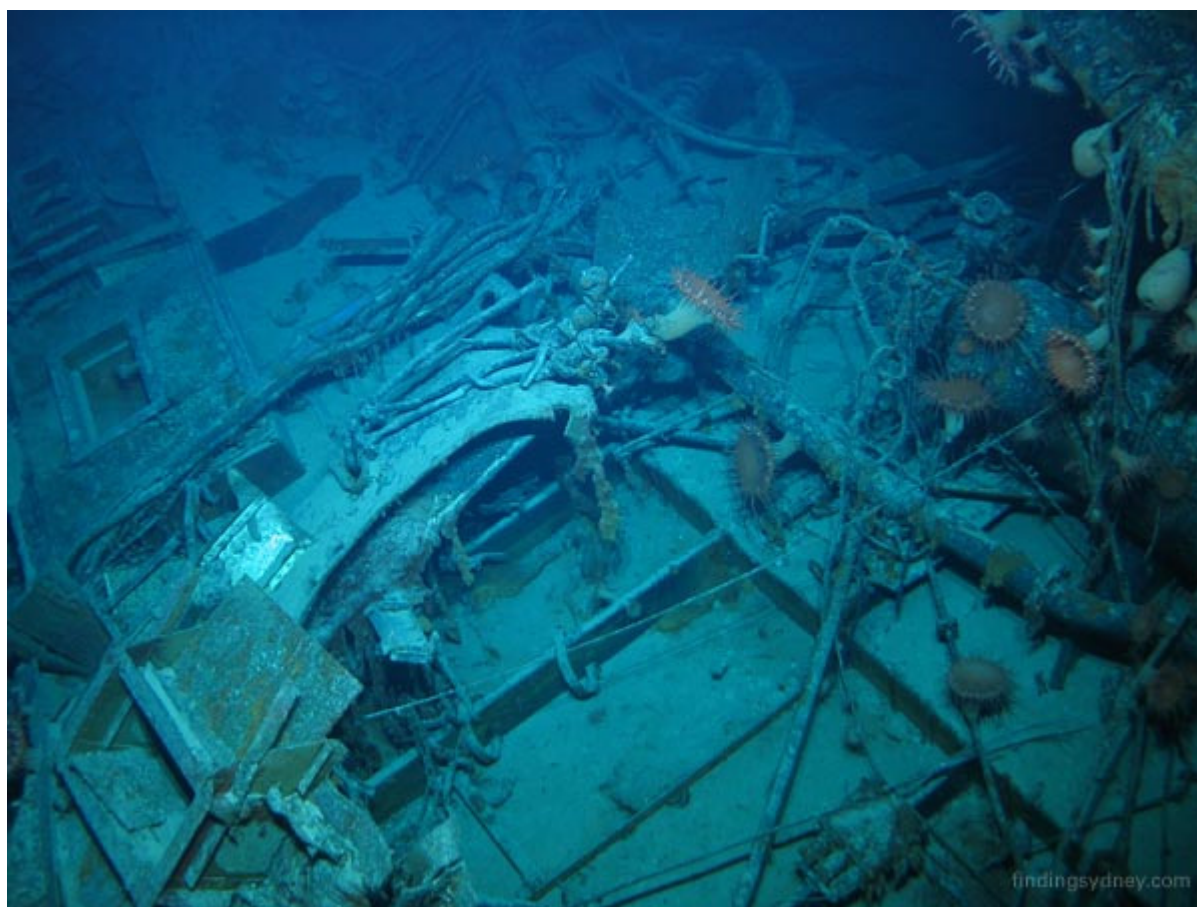
Above Photograph: Another large piece of wreckage shows a confusing jumble of pipes, cable and hull structure.

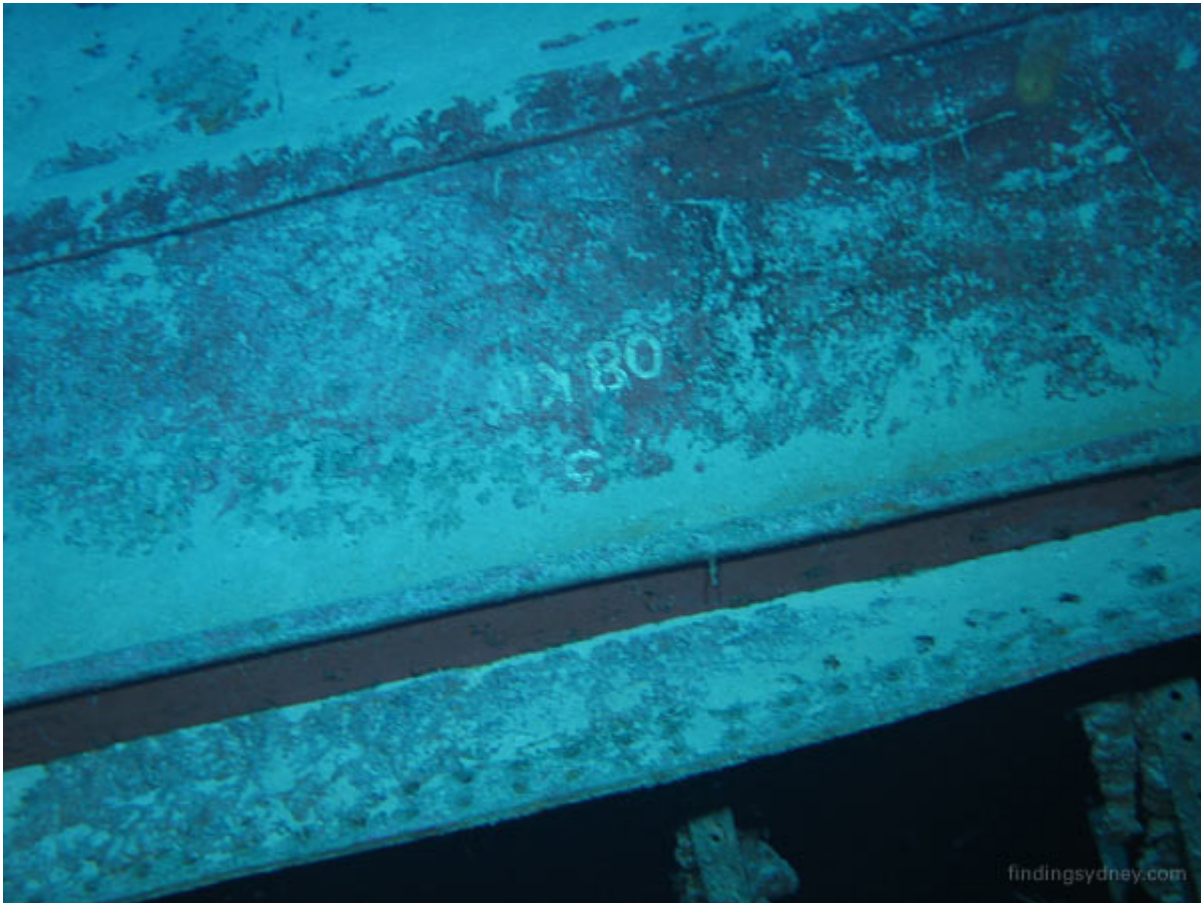
Above Photograph: The writing "08KO" painted in white on the hull just beneath the bilge keel identifying the wreck as HSK8 Kormoran. This is the actual photograph as taken by the ROV, but the image must be turned around to read the writing correctly.

The final unexpected bonus of this dive came when I spotted some writing on an enormous piece of wreckage that we struggled but finally succeeded in identifying as lower hull plate from Kormoran's port side. The only identifiable feature for orientation was the bilge keel running left to right, but just below it painted in white were the small number and letters "08KO". It is incredibly rare to find any writing on a shipwreck, never mind painted writing which is almost always obscured by corrosion and/or sedimentation. But there was little doubt that here on the underside of the hull in the most unusual of places was writing that positively identified the wreck as being Kormoran, the German auxiliary cruiser designated number 08.
